Case study // Caldew Retaining Wall

Network Rail

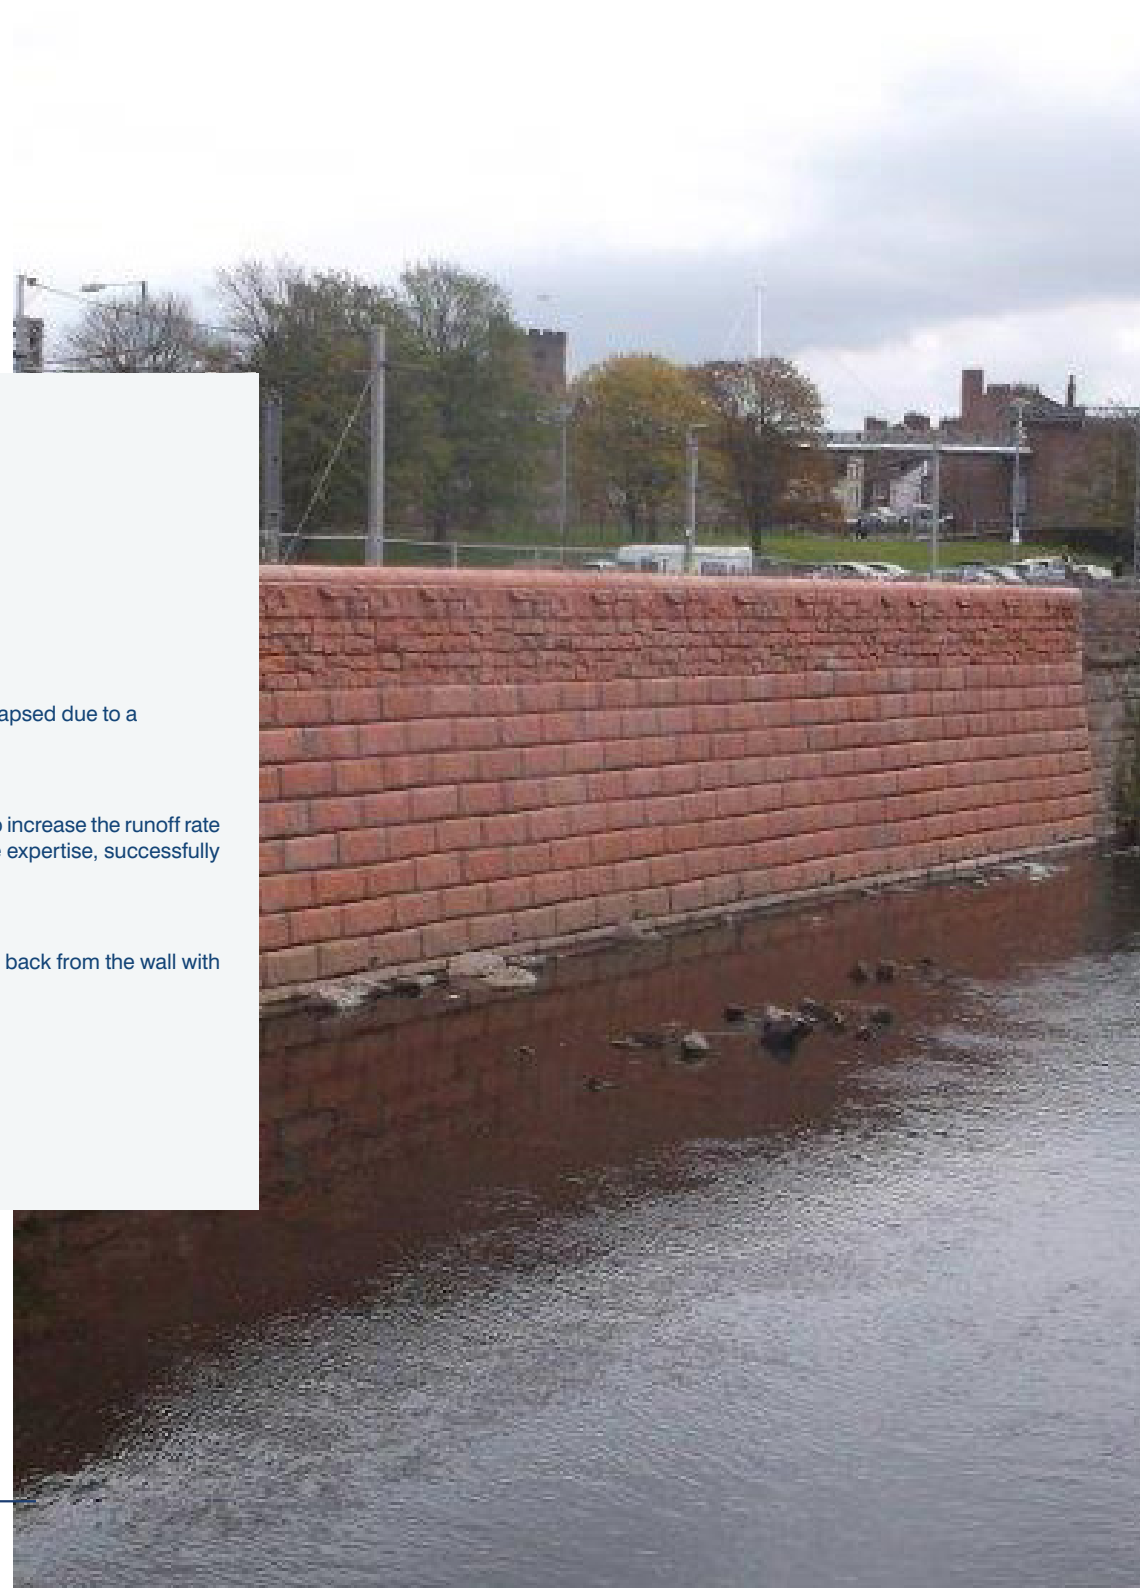
We were contracted to mitigate the risk of the already unstable bank alongside the railway track. The wall collapsed due to a combination of erosion, poor drainage and undercutting from the river current.

The emergency repairs had to be conducted immediately to prevent further destabilisation. We held the river back from the wall with sheet piling creating a temporary dam. This enabled excavation works to be carried out at river level.

We removed the collapsed wall and replaced it with new redi-rock blocks. A new drainage vent was installed to increase the runoff rate and prevent future saturation / destabilisation. The project delivery strategy was developed utilising in-house expertise, successfully completed, with its objectives delivered safely, on time and within budget.
